CARNEGIE-MELLON UNIVERSITY  
MELLON INSTITUTE

INVESTIGATION OF STRESS CORROSION CRACKING OF TITANIUM ALLOYS

Semi-Annual Progress Report No. 4  
for the Period  
December 1, 1967 through May 31, 1968

E. G. Haney and W. R. Wearmouth

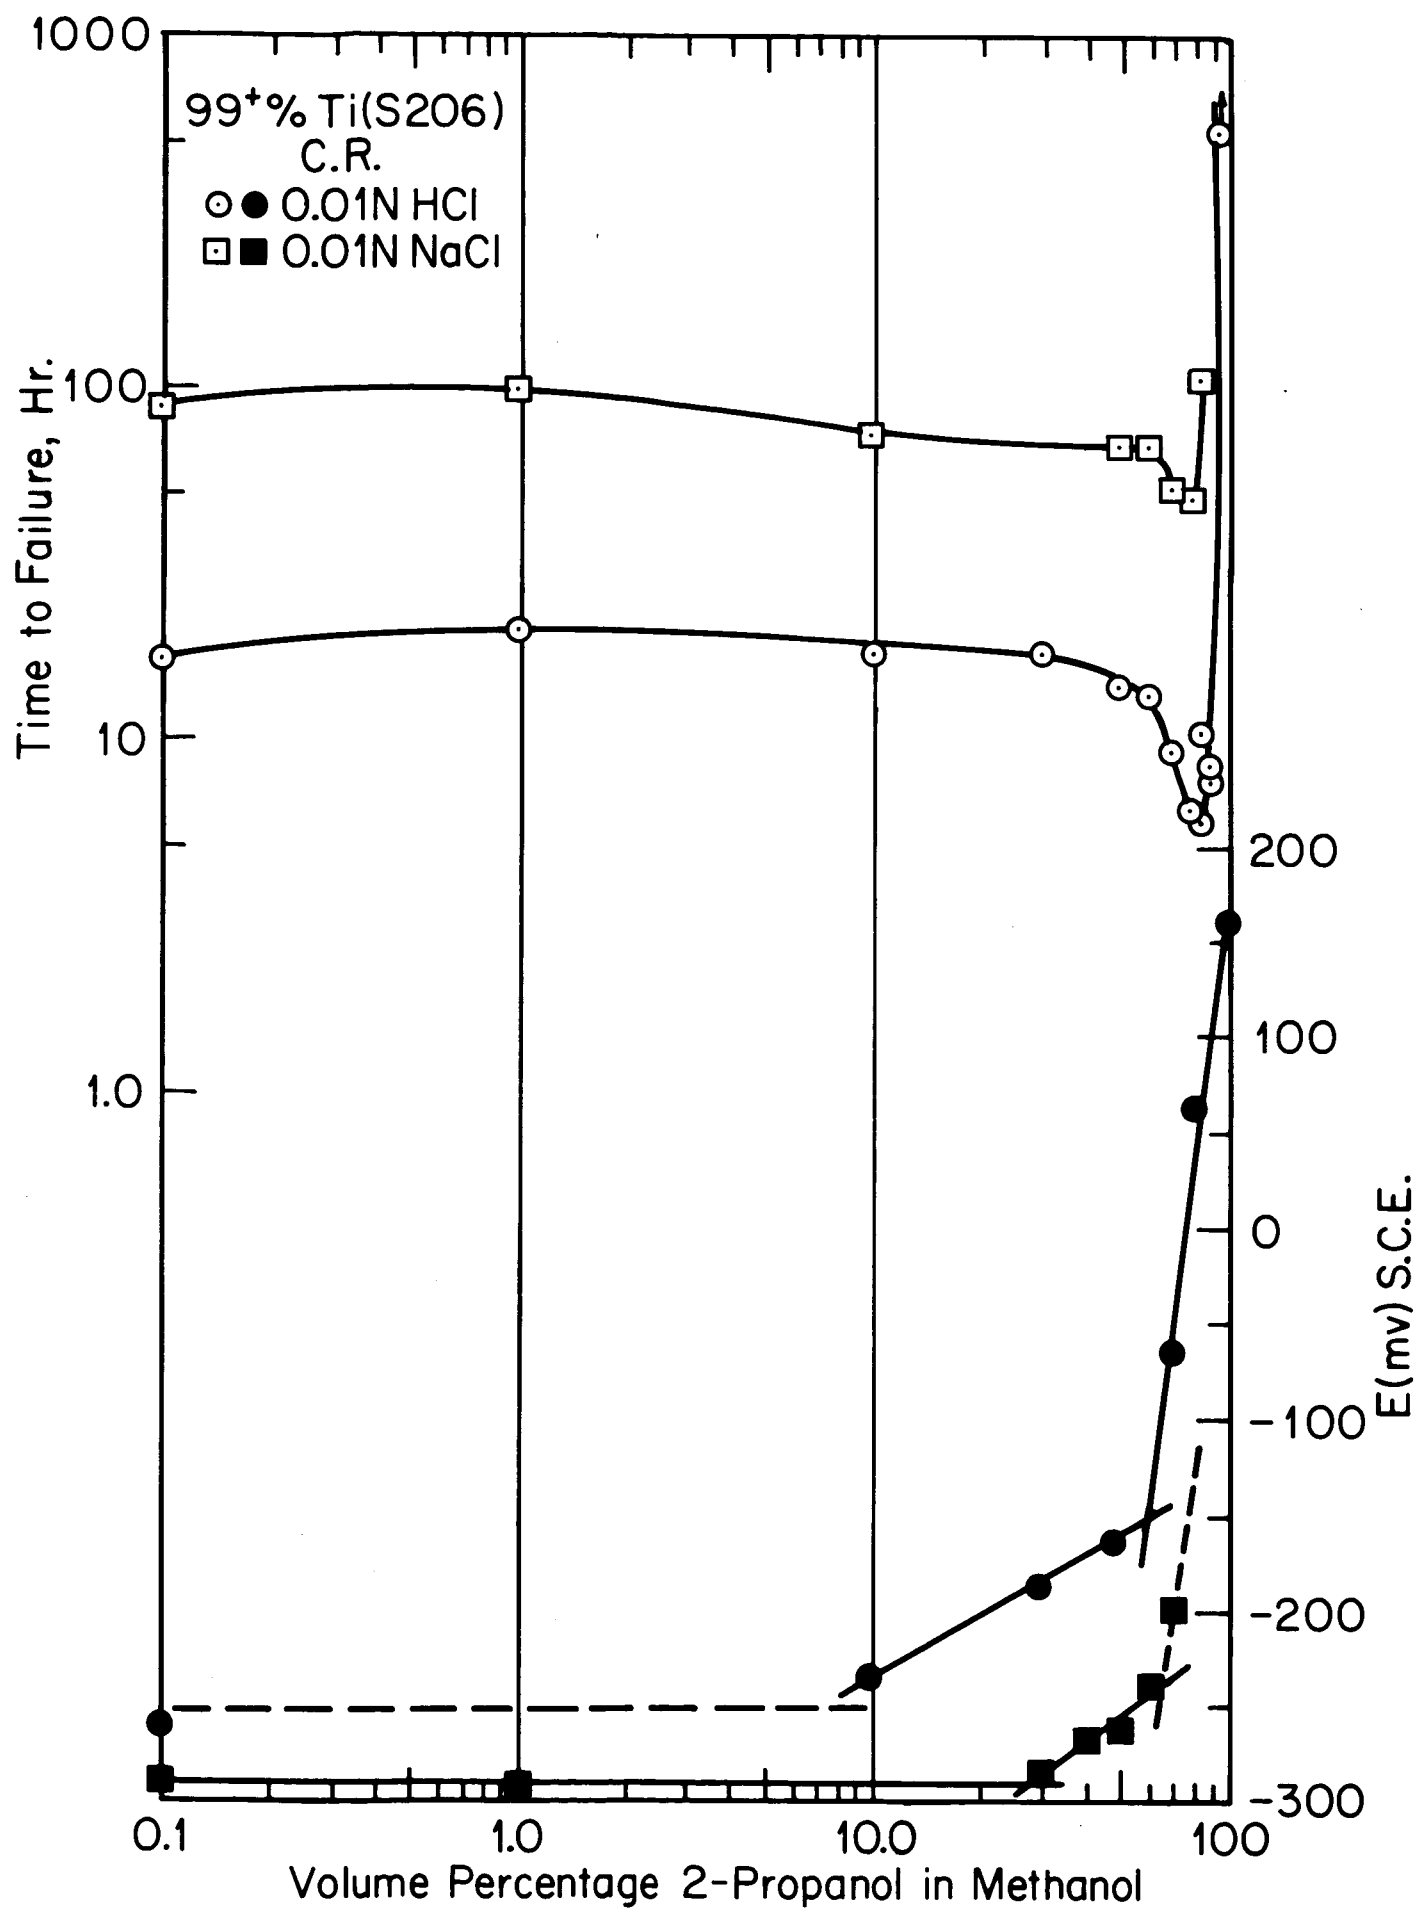
Figure 21 Comparison of time to failure with one-hour electrode potential values.

The water content alone can account for the apparent inhibiting effect of acetic acid, acetone, and MEK as shown in Figure 19 and comparing with Figure 18. Additional proof of the effect of water can be seen in Figure 20, which compared HCl with NaCl as additions. Note the water content differences for 10% MEK in the table. However, do alcohols prevent cracking by any reactions involving water. It seems doubtful, because the amount of water in n-octyl alcohol is about the same low water at 20% and 90% (see table). At the 20% n-octyl alcohol level, the foil was easily cracked; but the foil did not crack in 500 hours at the 90% level. The curves for 2-propanol have similar shapes whether NaCl or HCl was used (see Figure 21), again indicating no reactions involving water.

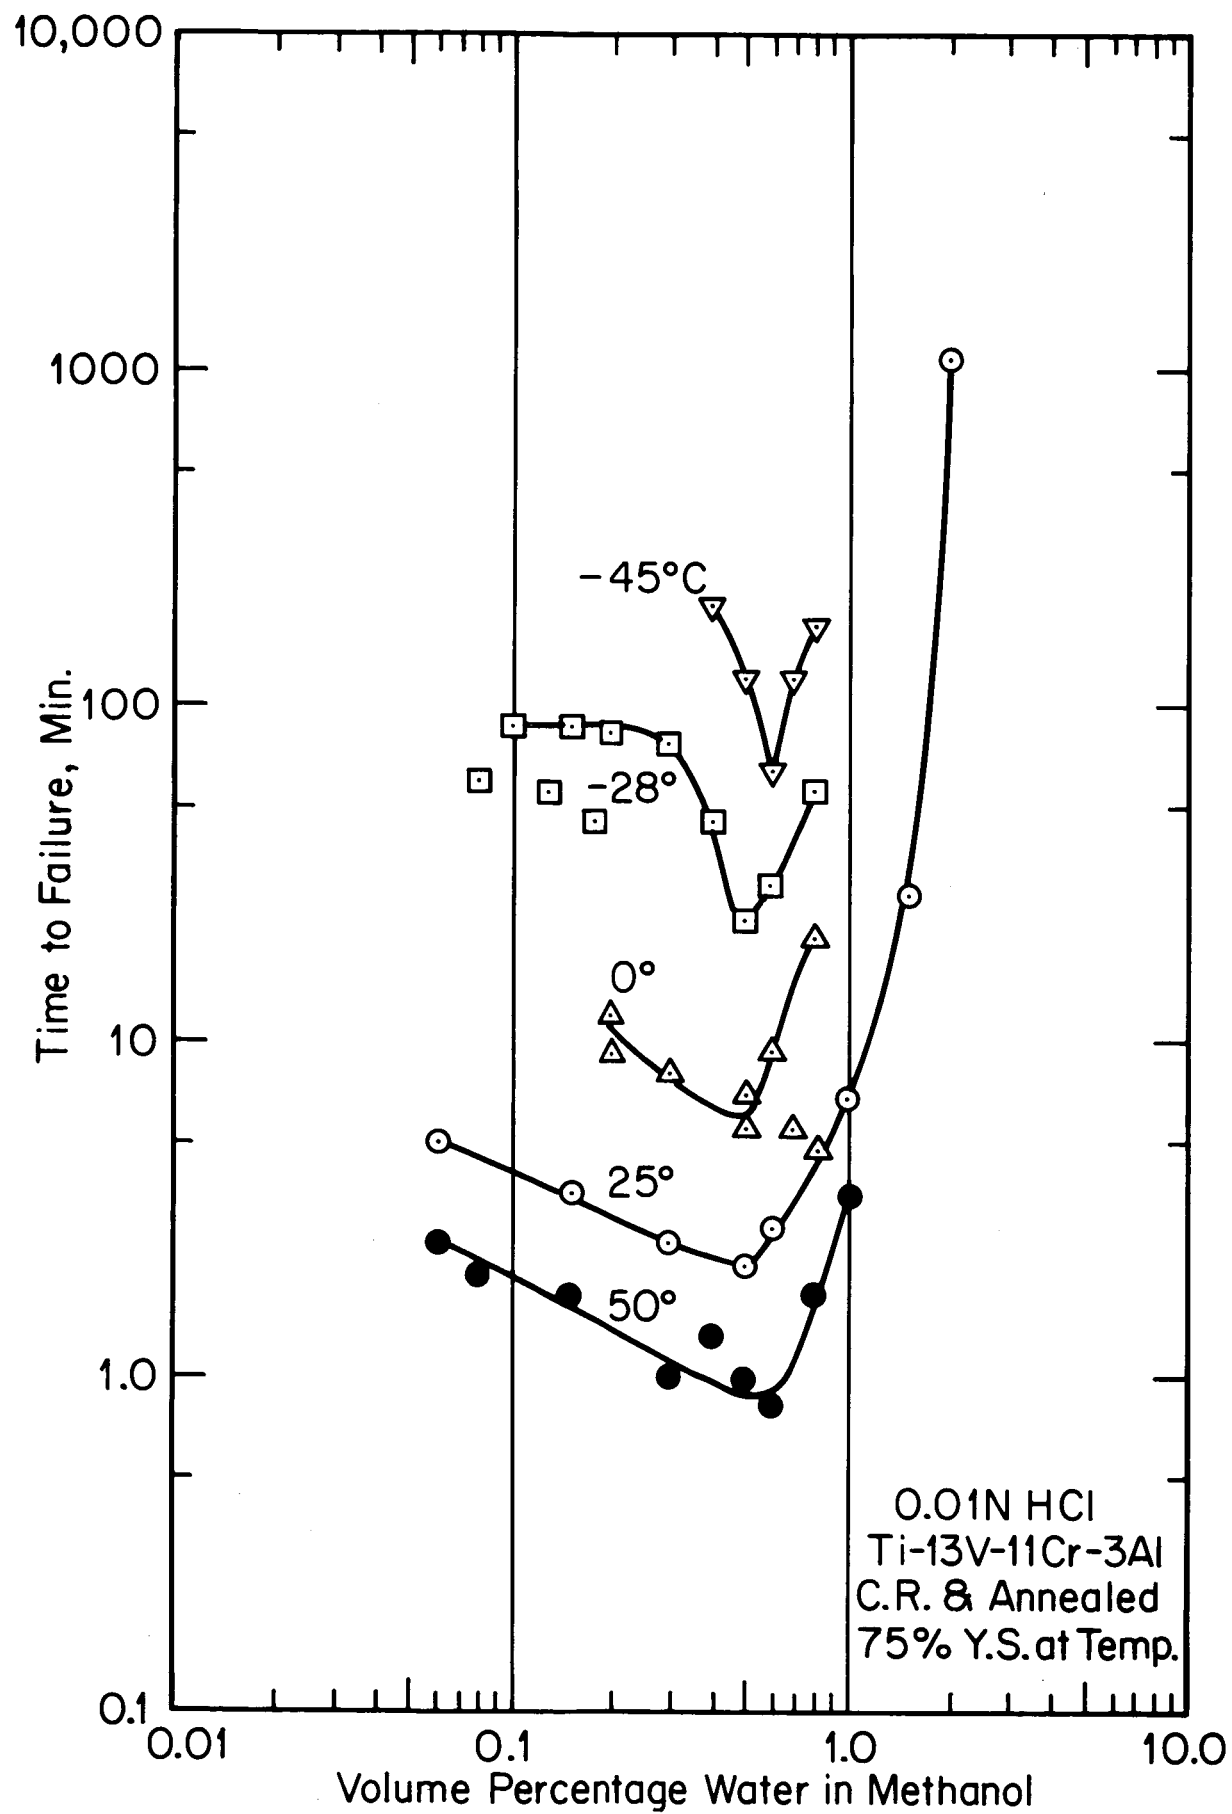
Figure 22 Effect of temperature on time to failure.

The dependence of the time to failure on the testing temperature was studied from 50°C to -45°C in methanol-water-chloride solutions for the Ti-13V-11Cr-3Al foil. The specimens were stressed to 75% of their yield strength at the testing temperature. The minimum in the curves occurred over a more restricted range of water contents as the temperature was decreased without much shift in position with respect to water; see Figure 22. If the shortest time to failure for each temperature is plotted against the reciprocal of the absolute temperature, a straight line is obtained; see Figure 23. An activation energy of 6.5 kcal/mole was calculated for this thermally activated process from the usual Arrhenius treatment of such data. The value is rather low for a chemical process but does correspond to the diffusion of hydrogen in beta titanium, 6.64 kcal/mole, as determined by Wasilewski and Kehl<sup>7</sup>. Additional work is currently in progress on the 99.5% Ti alloy to see if the activation energy obtained would correspond with the 12.8 kcal/mole value obtained for alpha titanium for hydrogen diffusion<sup>7</sup>.

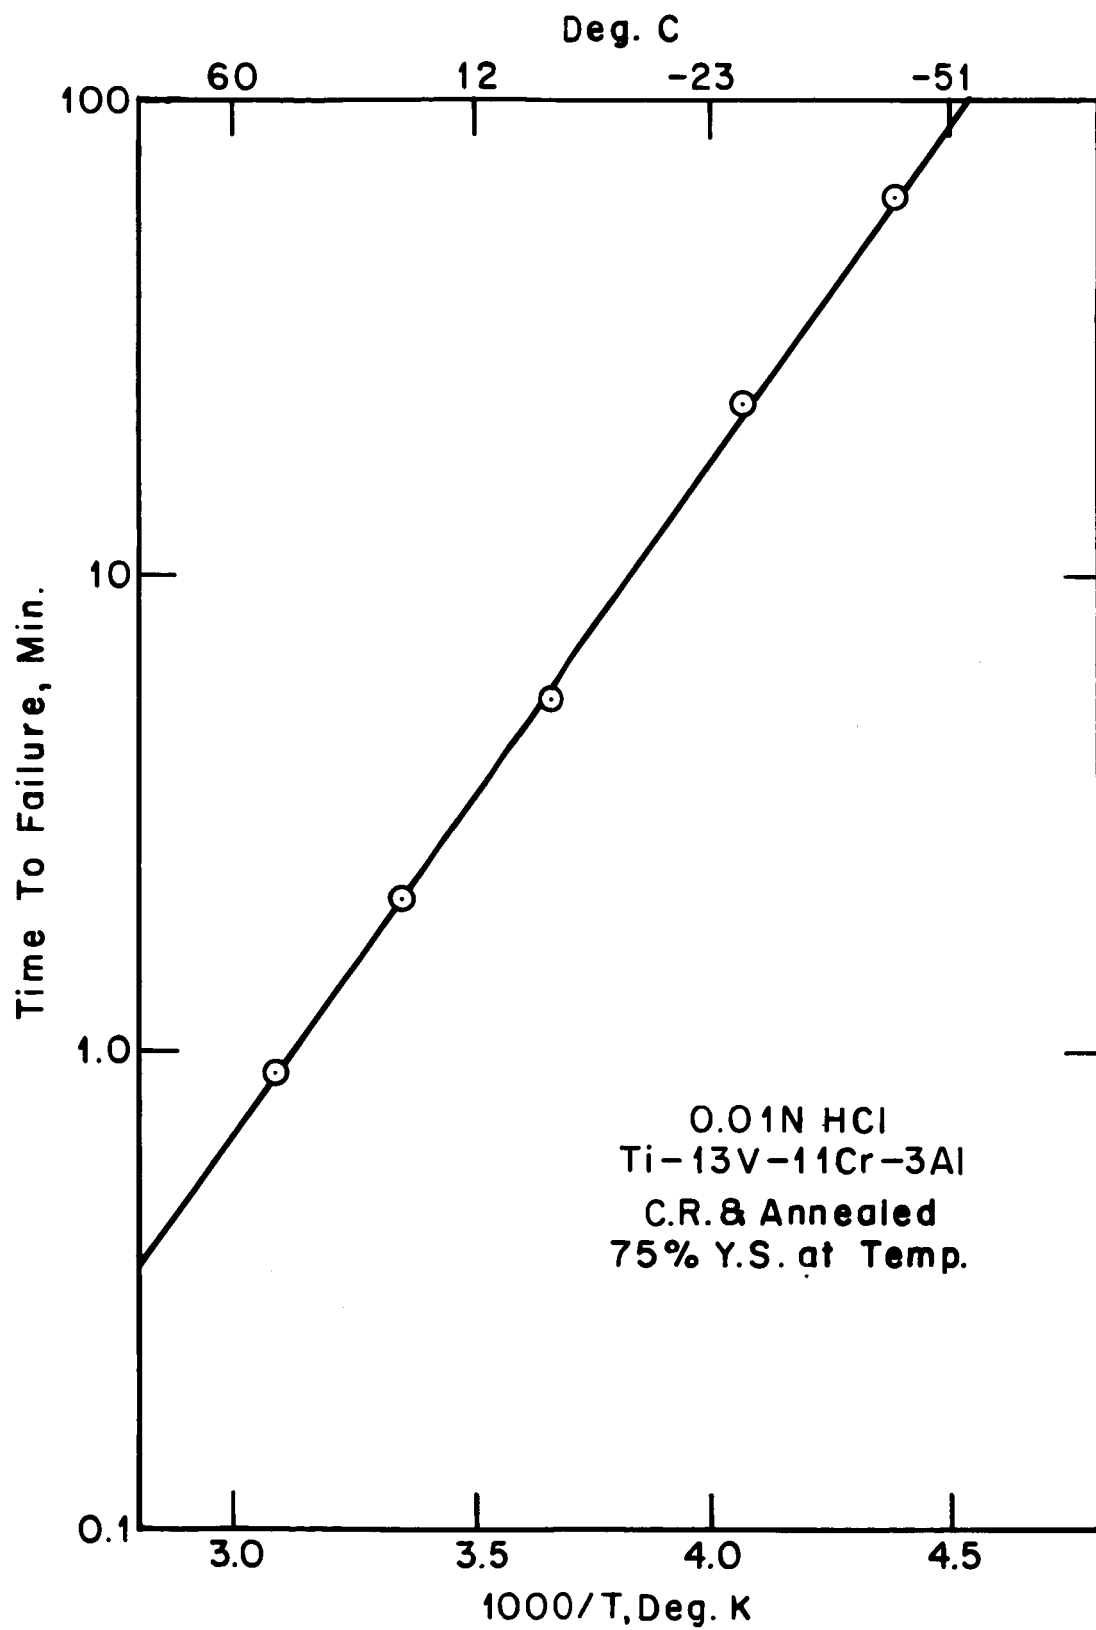
Figure 23 Effect of reciprocal temperature on minimum time to failure.
